**SOHO Mission Interruption Joint NASA/ESA  
Investigation Board**

**Final Report**

**August 31, 1998**

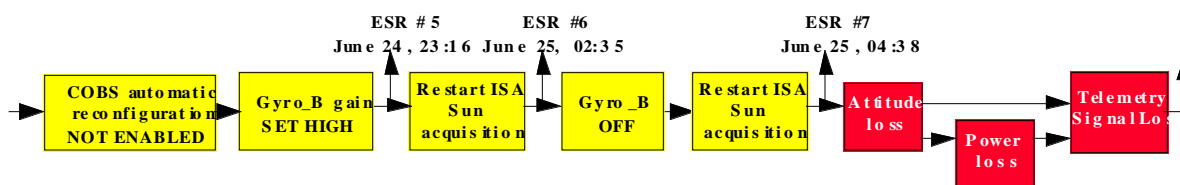
Diagram 1. Failure Event Tree - Top Level

The first two errors were contained in predefined command sequences executed from the Ground System, while the last error was a decision to send a command to the spacecraft in response to unexpected telemetry. The sequence of these errors and their relationship to the triggered-ESRs are graphically depicted in Diagram 1.

This series of events was preceded by a routine calibration of the spacecraft's three roll gyros. As stated earlier, the gyros are not required during most of the mission. They are used for thruster-based activities such as momentum management, ISA, and ESR.

Since the gyro calibration in the compressed timeline is immediately followed by the execution of momentum management, the previously employed procedure to despin the gyros at the end of the gyro calibration and to re-enable the on-board software gyro control function was not required. Following gyro calibration, Gyro A was specifically deactivated (despun) in order to conserve its life, while Gyros B and C remained fully active. Due to an omission in the modified predefined command sequence actually used, the onboard software function that activates the gyro needed by ESR was not enabled. **This omission resulted in the removal of the functionality of the normal safe mode and ultimately caused the catastrophic sequence of events.**

Following the momentum management maneuver, Gyro B, which is used for fault detection, was erroneously left in its high gain setting, resulting in an indicated roll rate of 20 times greater than actual. **The incorrect gain was due to an error in another predefined command sequence; this error resulted in an on-board fault detection output that triggered an ESR.** This ESR, the 5th since launch, occurred at 7:16 PM EDT (23:16 UT), June 24, 1998.
